INSPECTION REPORT

For the Property at:
123 EVS DRIVE
ROGERS, MN 55374

Prepared for: EVS INSPECTIONS
Inspection Date: Monday, November 2, 2020
Prepared by: Matt Edick

RE: Report No. 9219, v.5
123 EVS Drive
Rogers, MN
55374

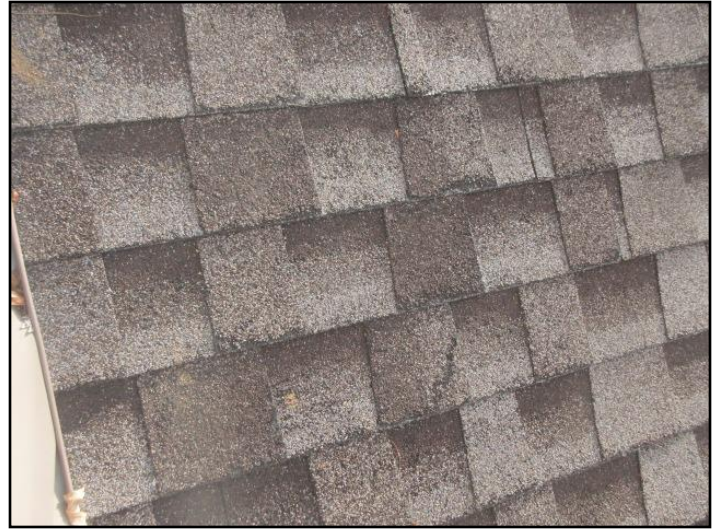
"Walk On" Lower Tier Roof Inspection

Some Granular Loss On Cosmetics Of Aging

Probability of leakage: • Medium

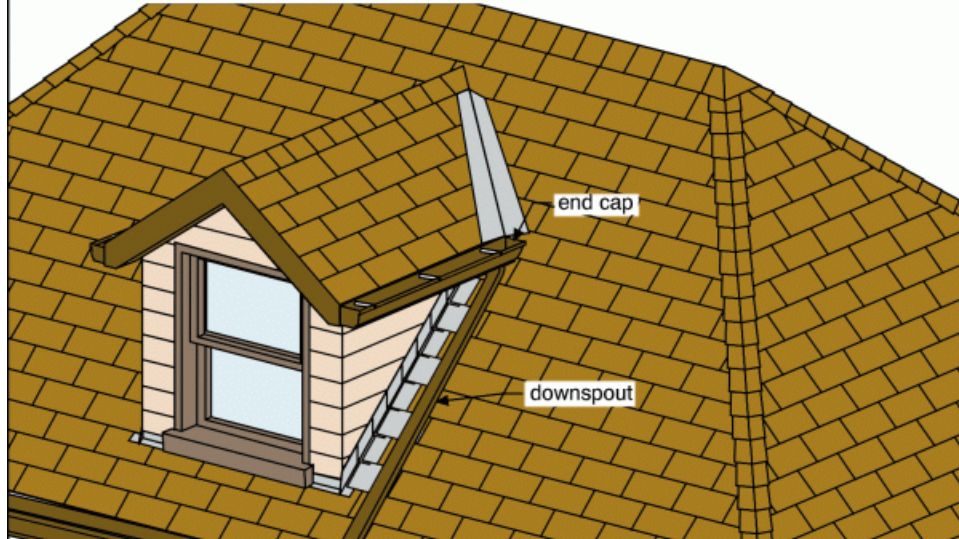
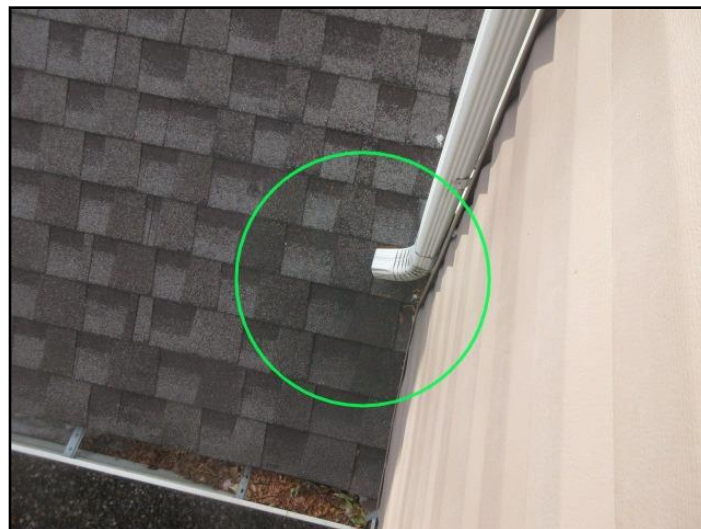
Discharge Onto Roof

1. Condition: • Discharge onto roof

Although this is installation standards unless specified. Downspouts that discharge onto second roof will exhibit more wear than the rest of the shingles. It is more ascetically pleasing not having downspout extensions going across a roof but better for life expectancy of shingles. More water discharge equals more granule loss, the granules are there to protect the asphalt coating from powerful UV ray penetration. Think of it like a waterfall eroding rock below.

Although this is installation standards downspout extensions that discharge onto second roof will exhibit more wear than the rest of the shingles. It is more ascetically pleasing not having downspout extensions going across a roof but better for life expectancy of shingles. More water discharge equals more granule loss, the granule are there to protect the asphalt coating from powerful UV ray penetration. Add extension to divert to lower gutter span. \$50-\$100

Add extension upon next roof replacement.

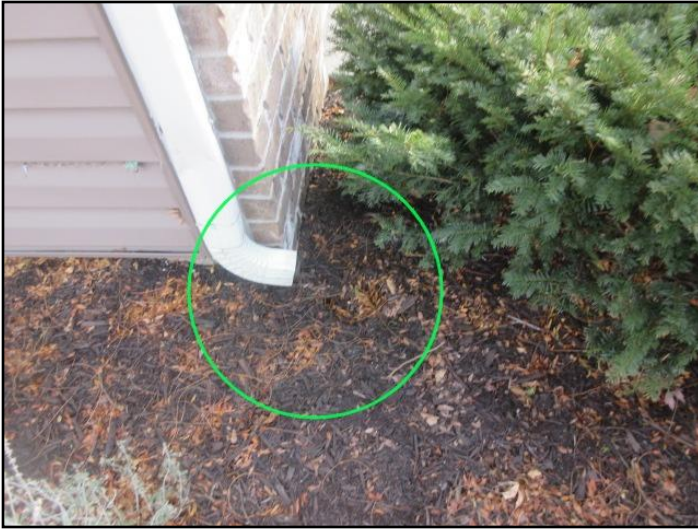
Missing Extension Front

Re-secure and replace missing or disconnect down spout extensions. We need to shed water 4-6' away from the home.

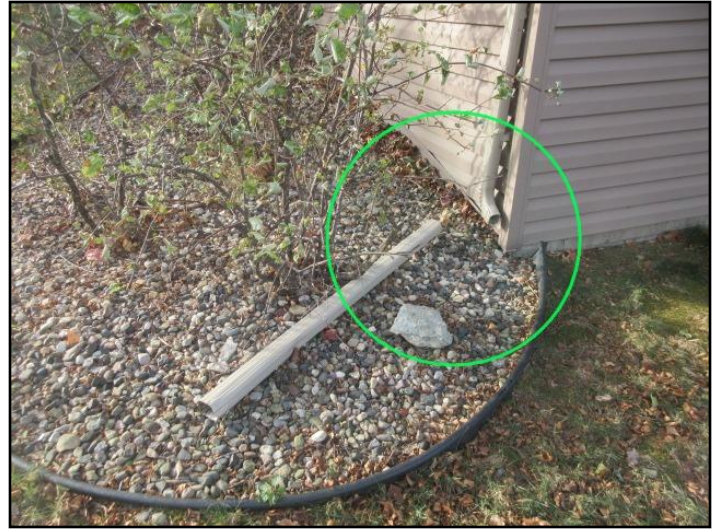
Disconnected Rear Extension

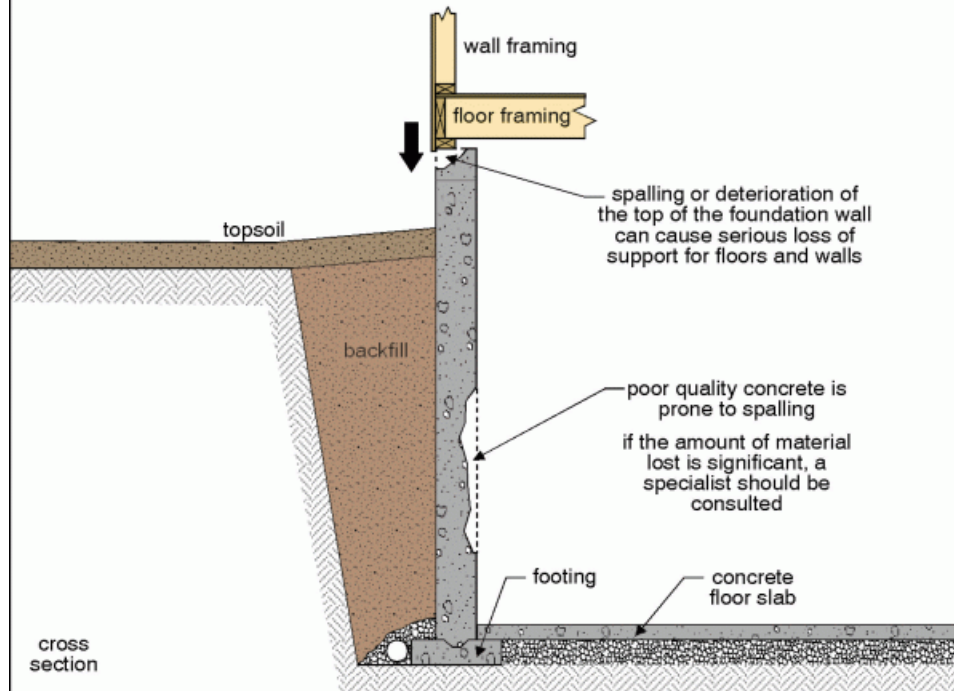
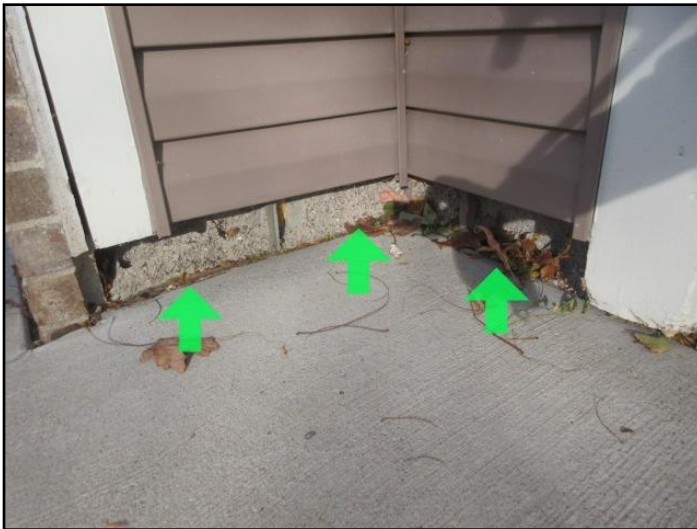
Exterior Front

9. Condition: • [Spalling, crumbling or broken material](#)

Spalling of poured concrete foundations

Have the garage foundation looked at by a licensed professional.

Protect the area by adding high strength concrete to the areas that are deteriorated, loose, missing. Pack material in place so it is supporting the bottom plate. Use wood as forms to re-build block shape. Continue to monitor and protect. Keep salt away from these areas. This could lead to structural failure if left unattended.

Ensure the old material is sprayed with water before applying new material. This makes for a longer lasting repair and prevents the old material from sucking all the water out of new material that is added.

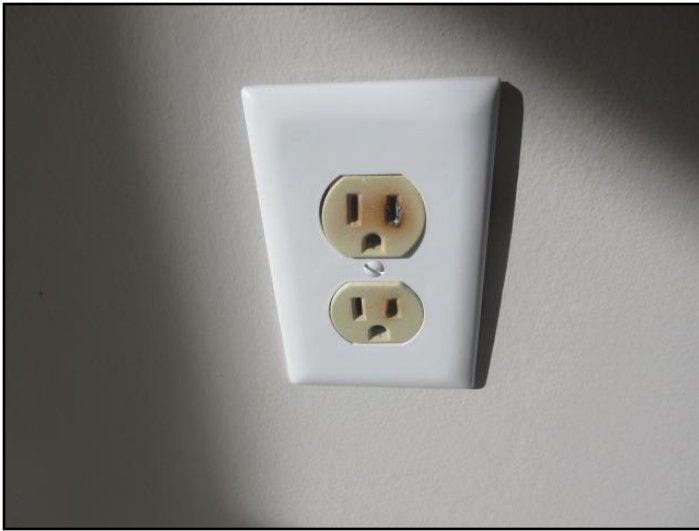
Damaged Outlet

Replace the affected outlets and continue to monitor for future issues in these locations.

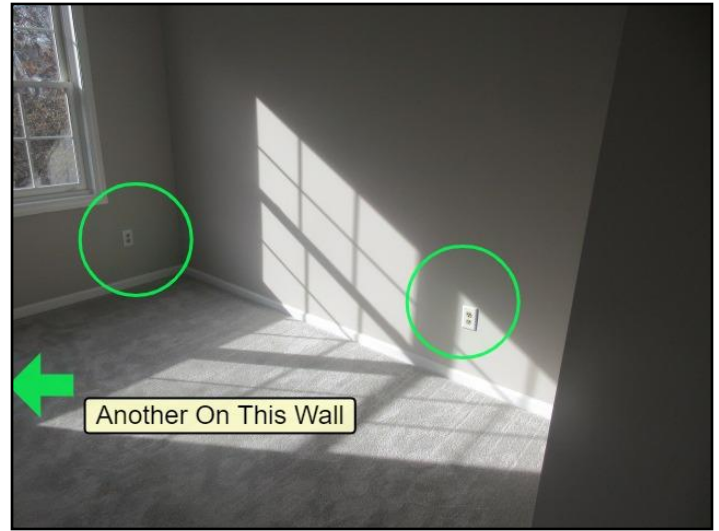
Few Outlets Bent Same Room

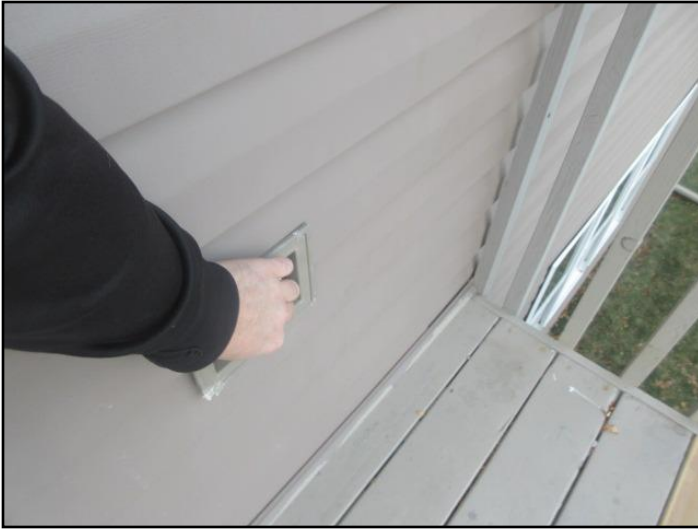
Loose Rear Deck Outlet

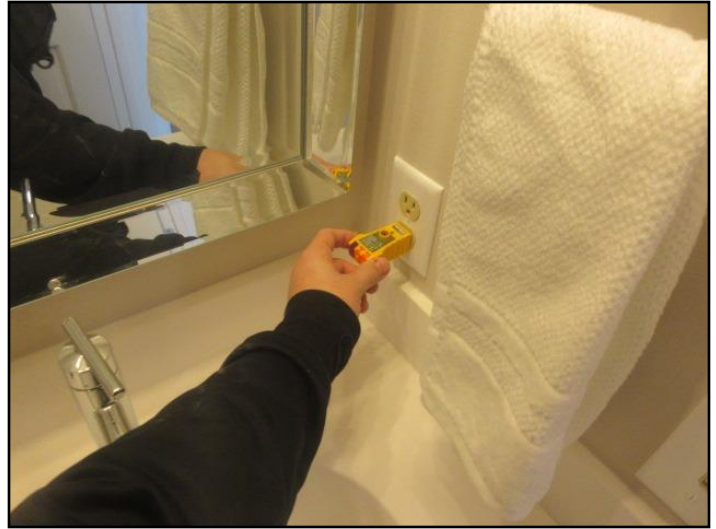
Loose Main Floor Bath Outlet

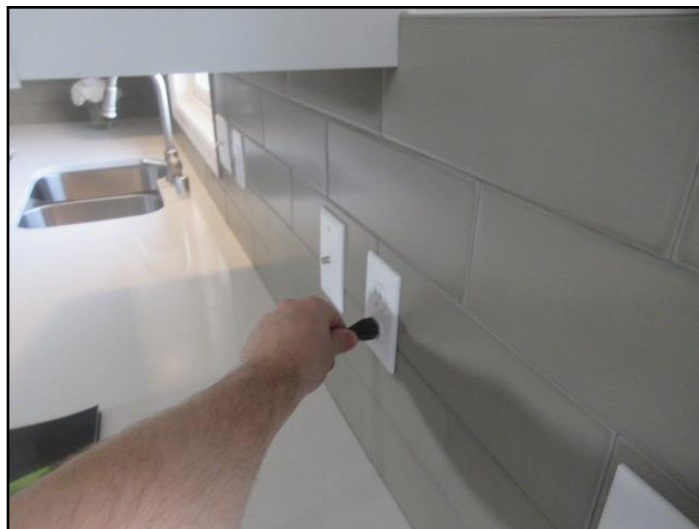
Loose Kitchen Outlet

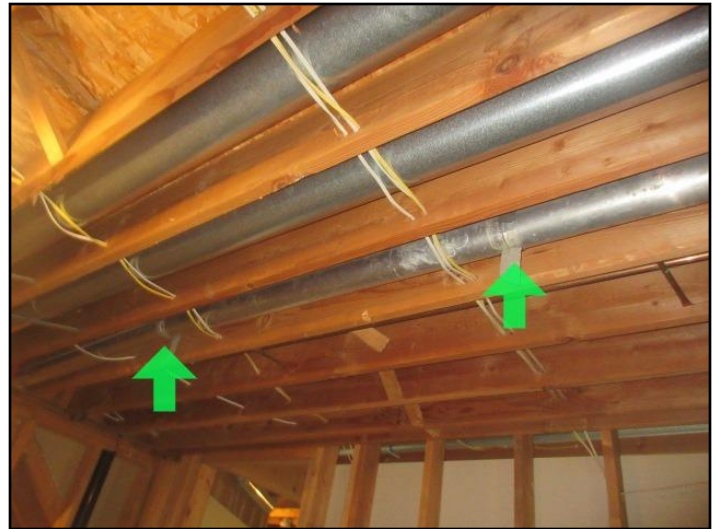
Duct Tape On Joints

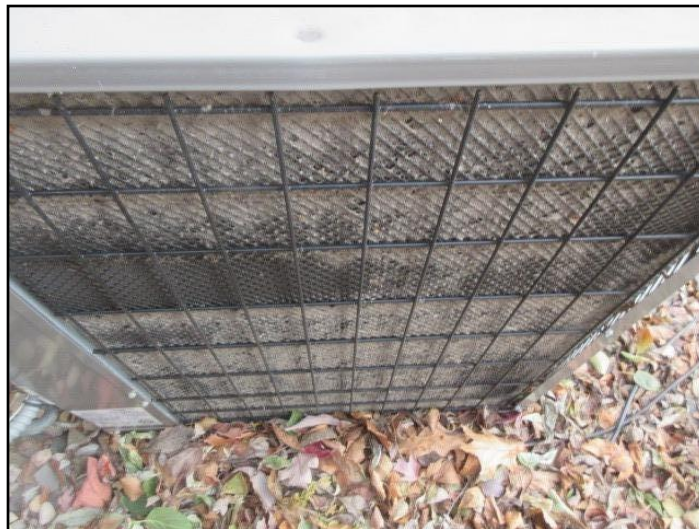
Unit Is Dirty

Consider covering your exterior AC unit during the colder seasons to lengthen its life expectancy. Use a cover that is made of breathable material, so moisture does not get trapped to cause rust or decay.

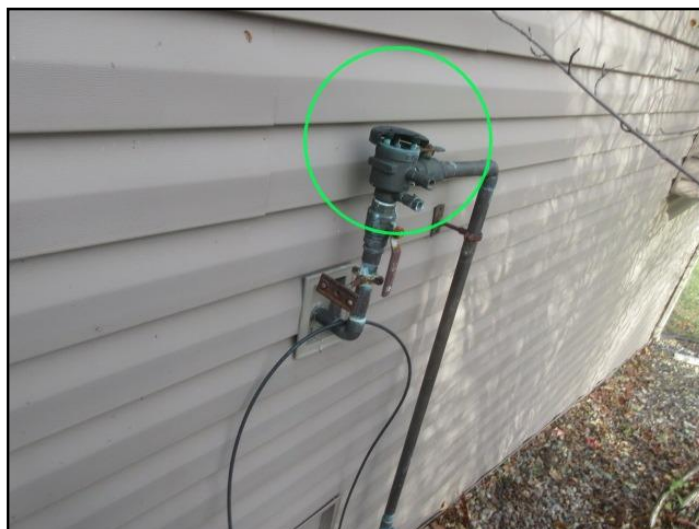
Back Flow Preventer Cap Damaged

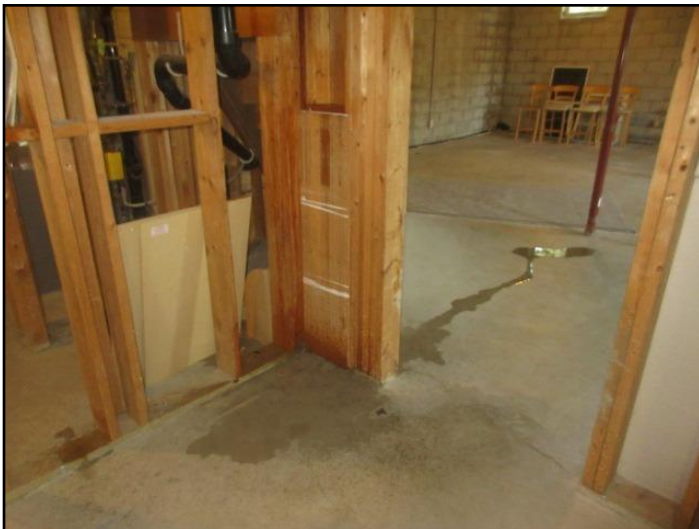
Leaking Followed Through Into Bsmt.

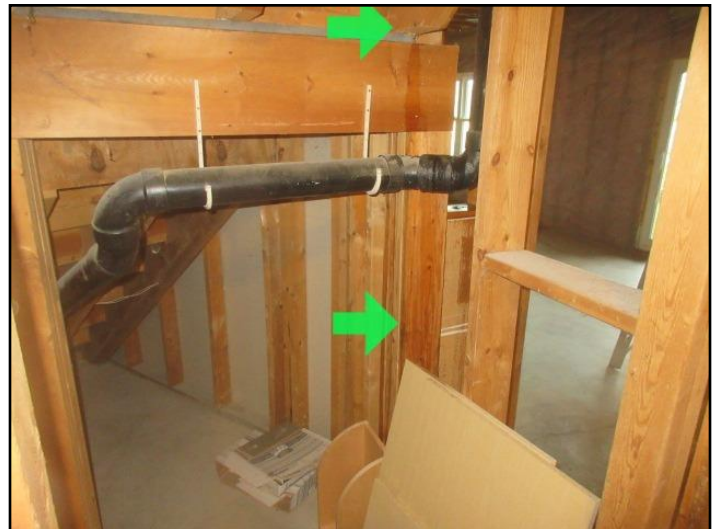
Leaking Followed Through Into Bsmt.

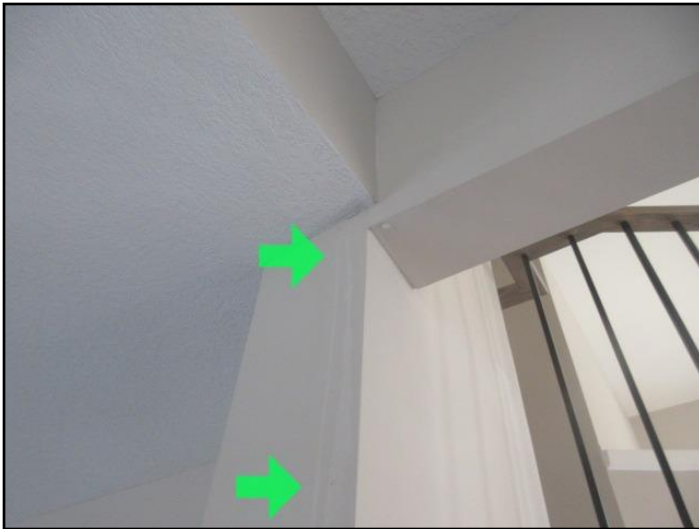
Water Leaking From Dining Room Ceiling

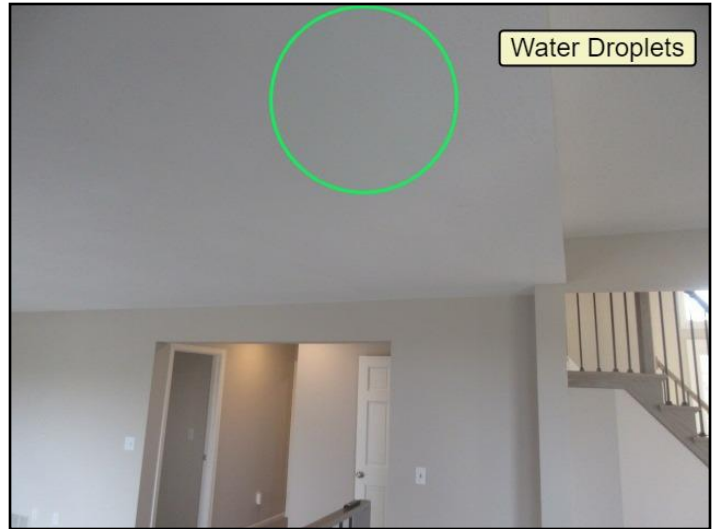
Water Leaking From Dining Room Ceiling

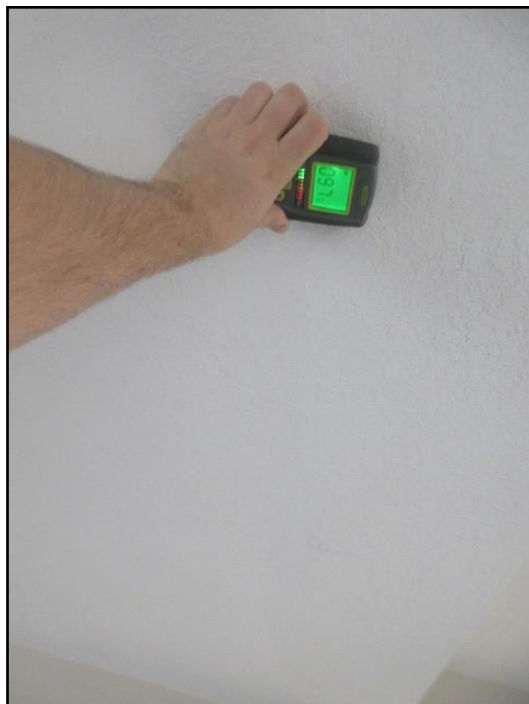
High Moisture Found In Dining Room Ceiling

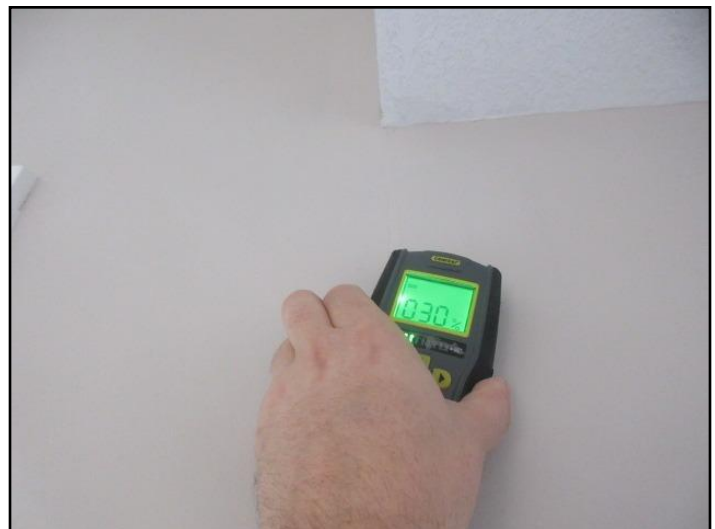
High Moisture Found On Exterior Rear Wall MB

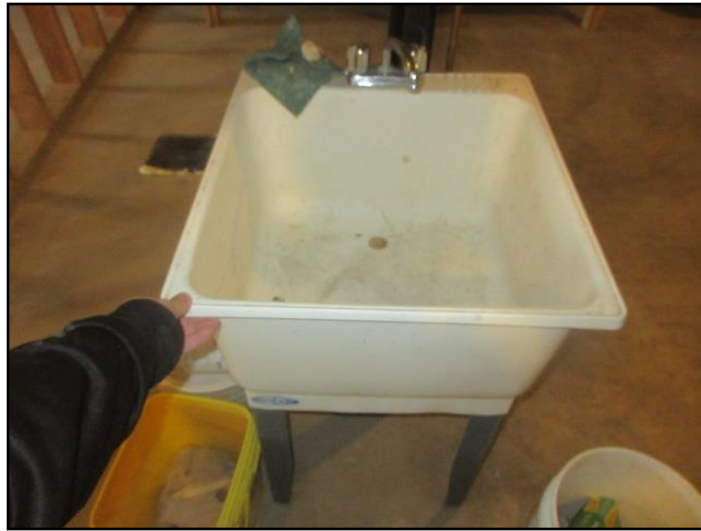
Sink Is Loose

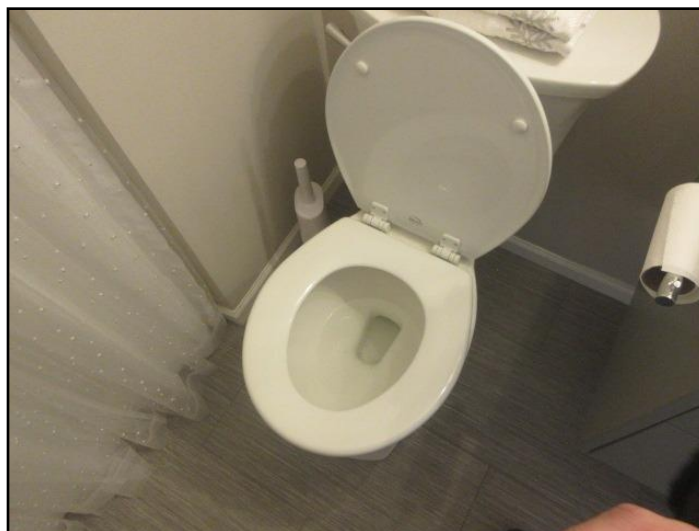
Loose toilet

Main Level Bath Slight Wobble In Toilet

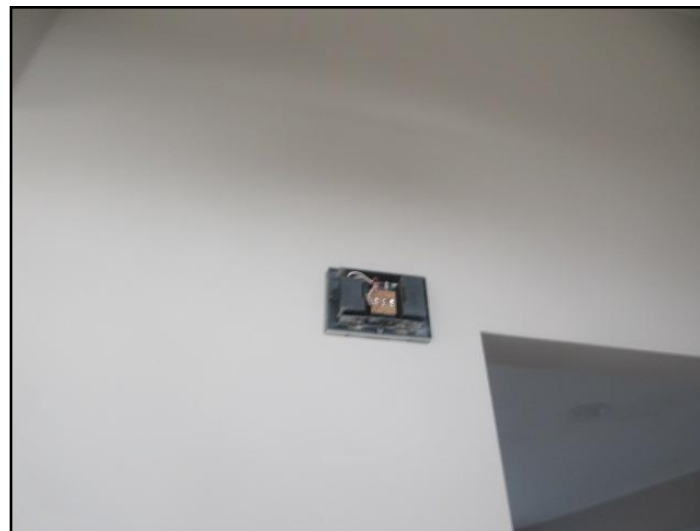
Functional But Missing Chime Cover

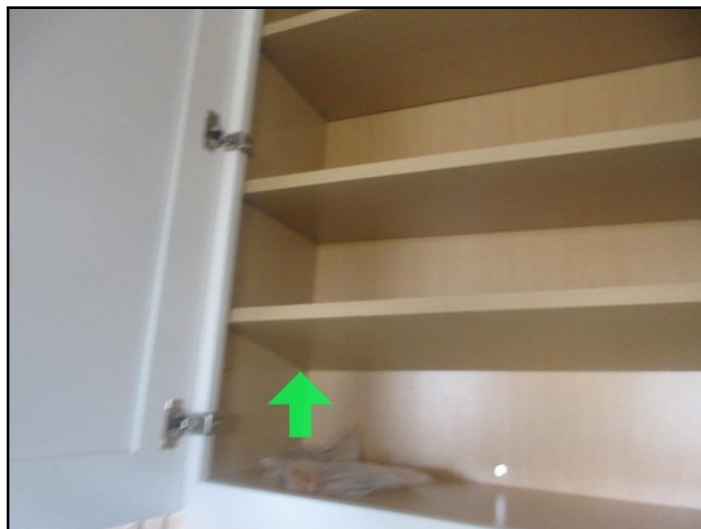
Missing Cabinet Bracket

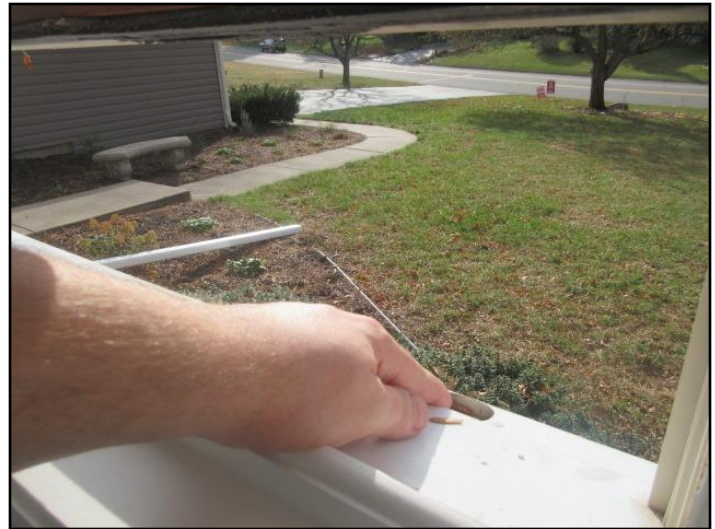
Damage To Outer Cladding ML Front Window

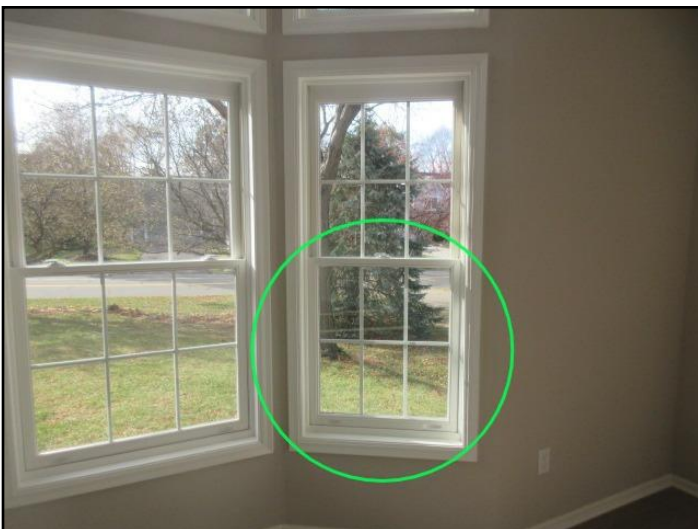
Main Level Front Living Room Inoperative

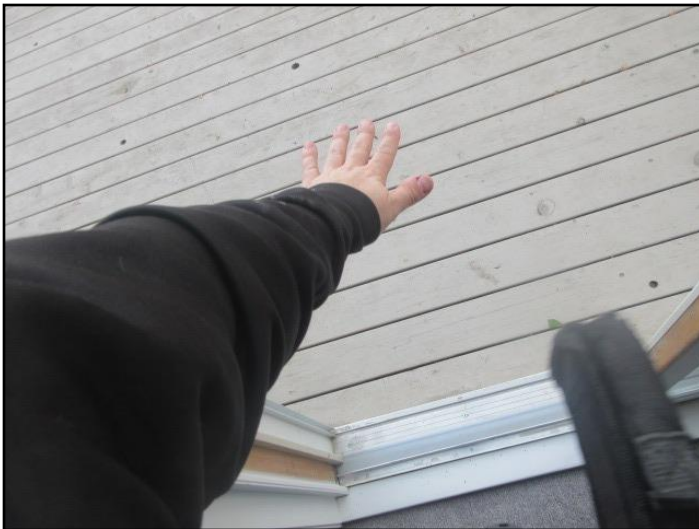
Main Level Missing Screen Door

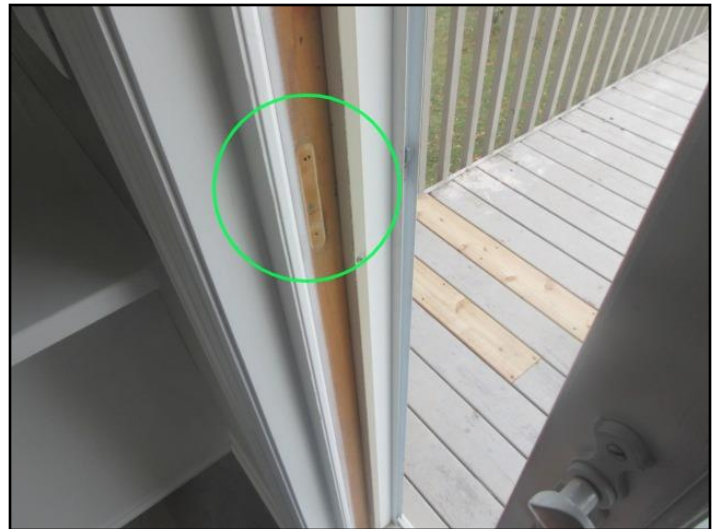
Main Level Patio Missing Lock Strike Plate

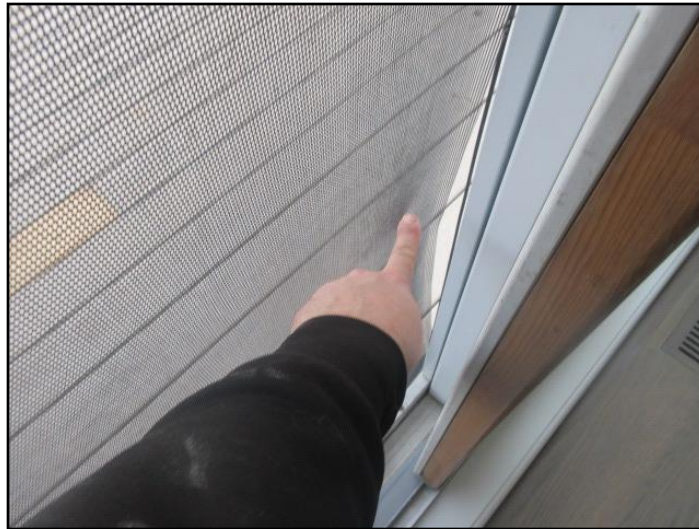
Main Level Loose Screen Door
