INSPECTION REPORT

For the Property at:
123 EVS DRIVE
ROGERS, MN 55374

Prepared for: EVS INSPECTIONS
Inspection Date: Monday, November 2, 2020
Prepared by: Matt Edick

RE: Report No. 9219, v.5
123 EVS Drive
Rogers, MN
55374

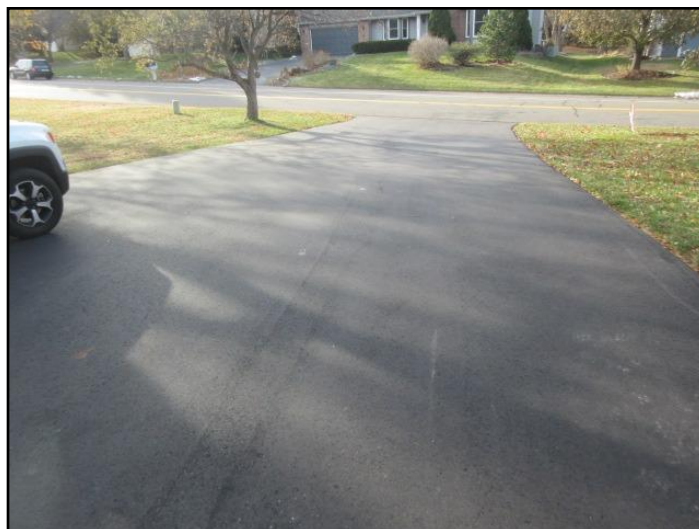
• No performance issues were noted.

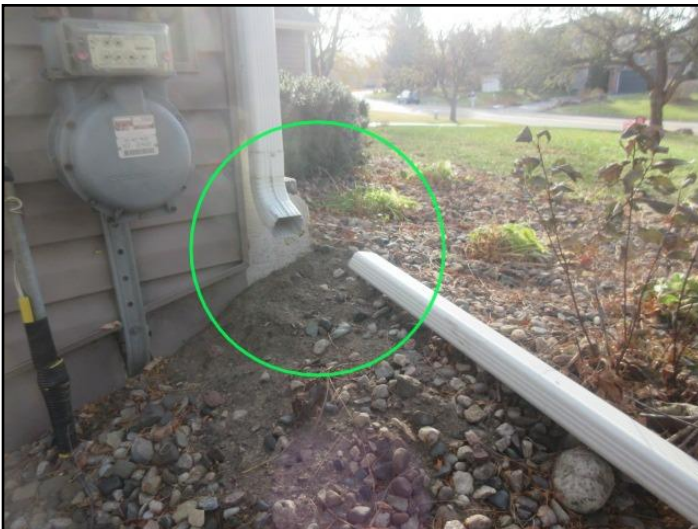
Disconnected Rear Extension

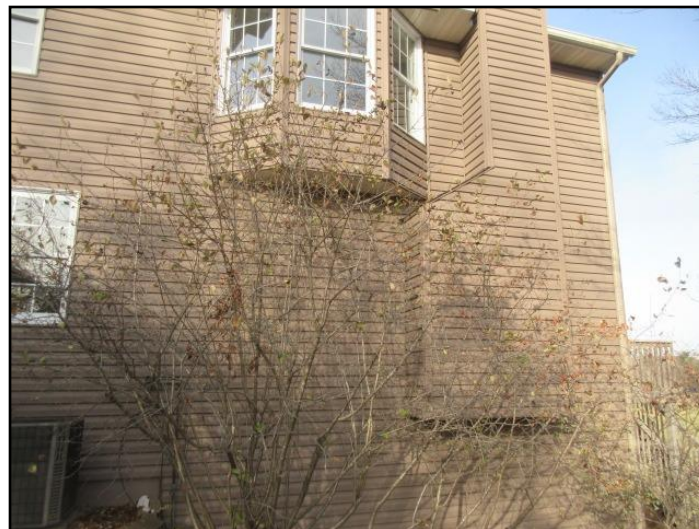
Encroaching Vegetation

7. Condition: • [Trees or shrubs too close to building](#)

Implication(s): Chance of water damage to structure, finishes and contents | Chance of pests entering building | Material deterioration

Time: Ongoing Regular maintenance

Cost: Less Than \$50

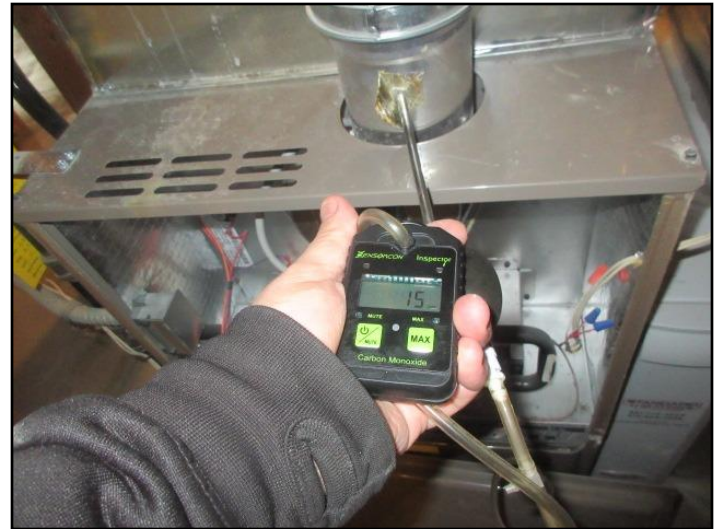
Combusting @ 15 PPM's

- Static Pressure Test
Not performed limited access.

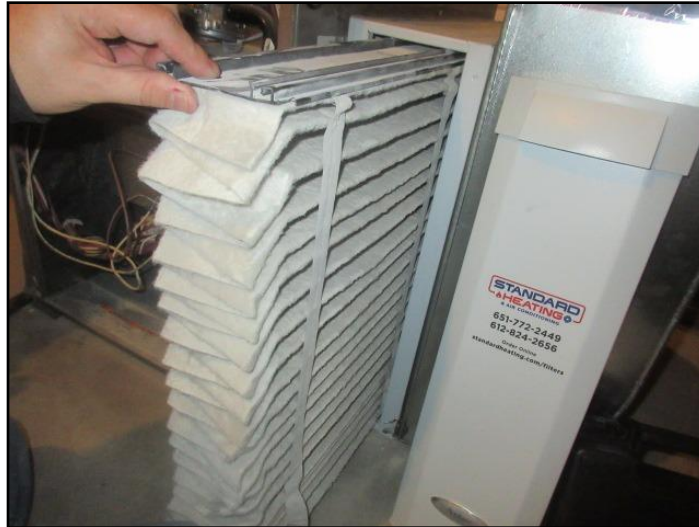
Model 213

Clean every 3 months and replace media annually.

Disposable filters 1" thick MERV 5 and under is recommended.

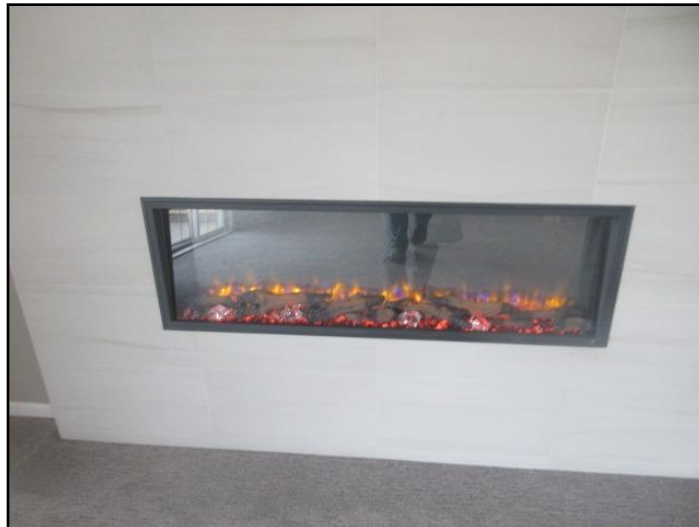
Electric Fireplace Operated

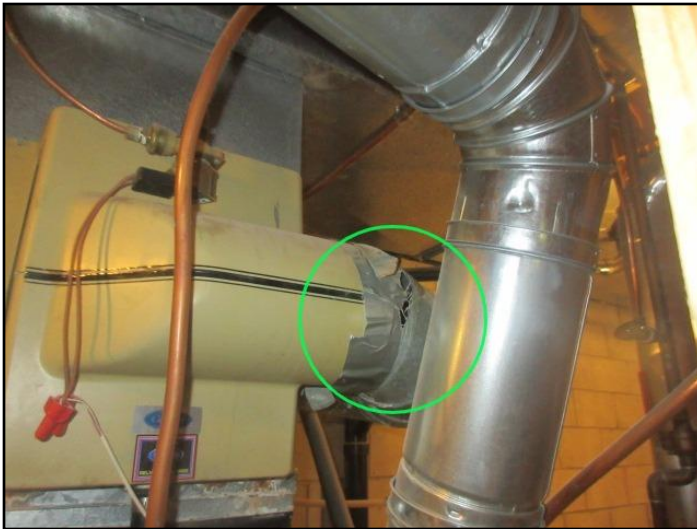
Poor Connection On Humidifier

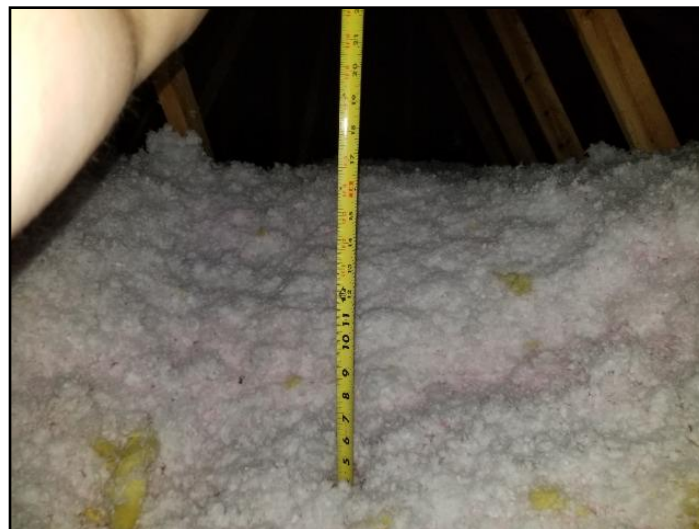
Insulation Verified

Try adding a cardboard scuttle so the insulation could be spread evenly around hatch opening.

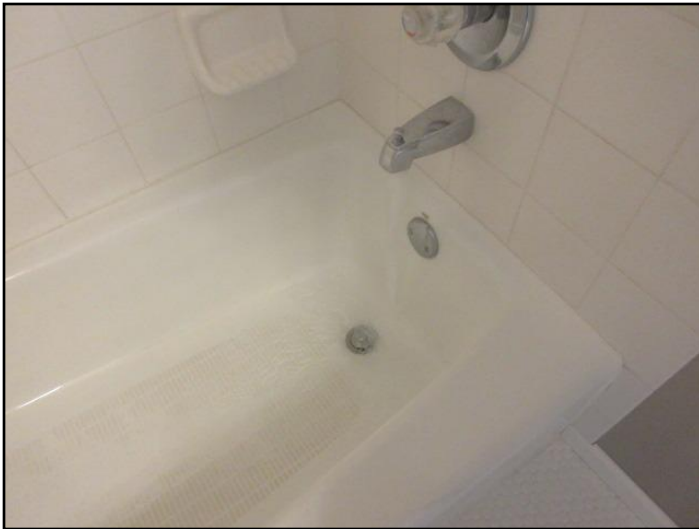
Tub Over Flow Not Tested

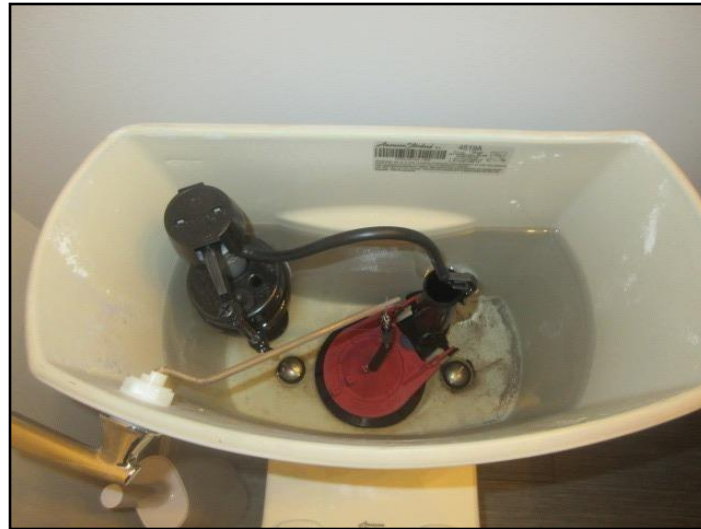
Toilets Functional

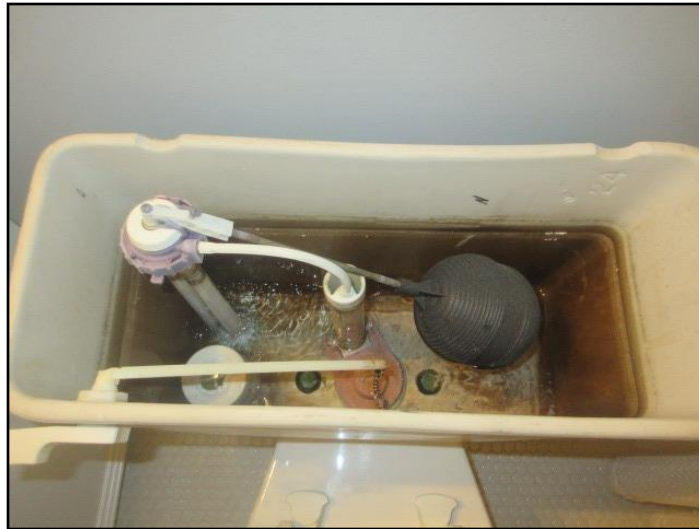
Toilets Functional

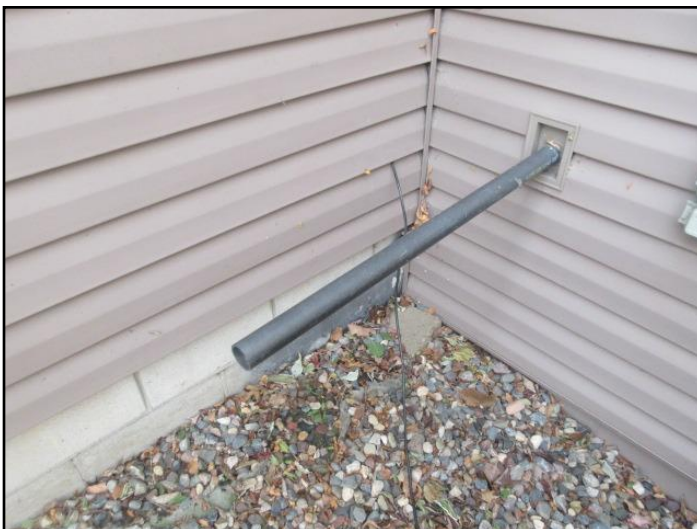
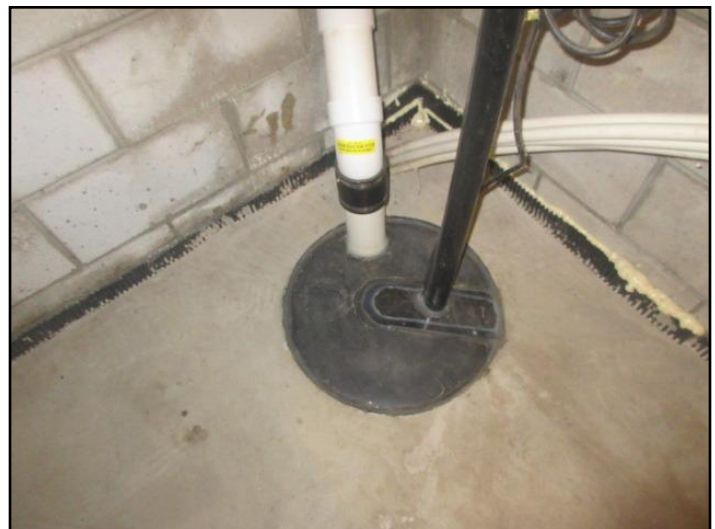
Sump pump not operated due to sealed lid. Continue to monitor basket for water accumulation and pump use frequency.

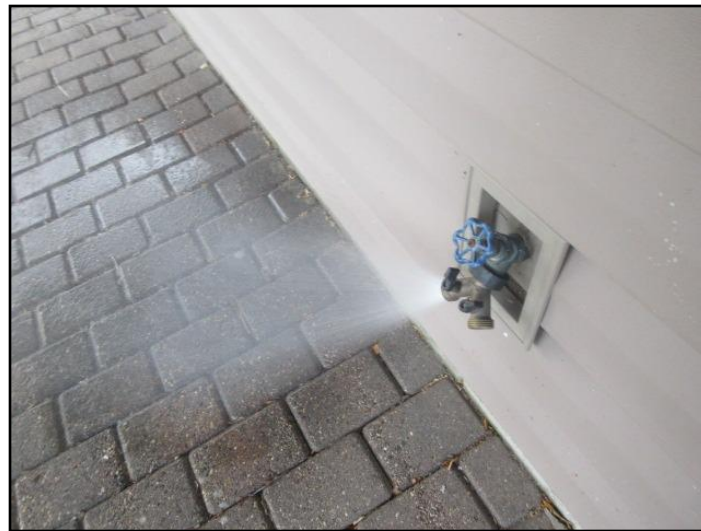
Rear Spigot Operated

Ensure to winterize other spigot as soon as possible. Have it in writing that the other spigot is functional.

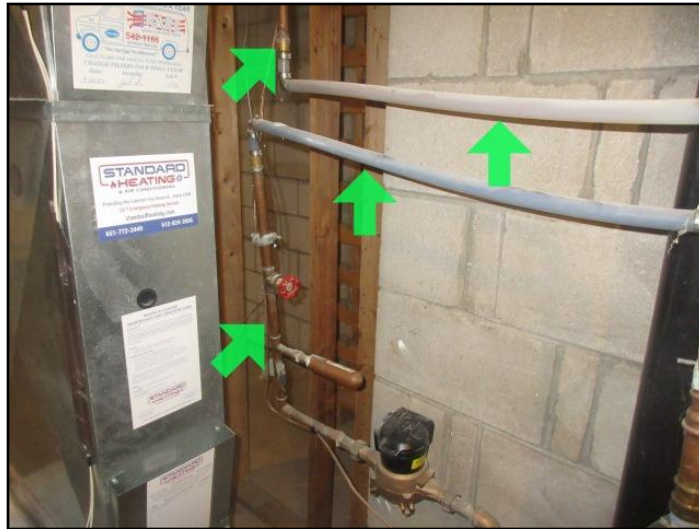
Near Water Meter

Replace plastic cover as needed. Cosmetic only. I was able to view this while the irrigation system was running during winterization. No water was spewing from cracked portion.

Continue to hire out for winterizing, that way your protected against damages. \$50-\$150.

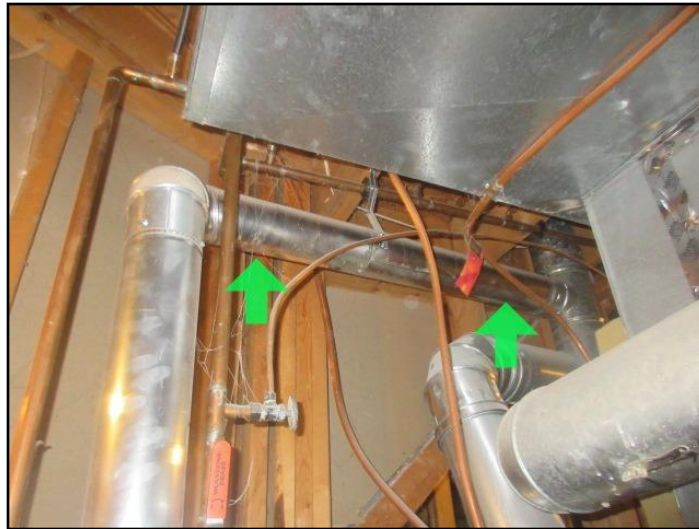
Poor connections

Water Heater Venting

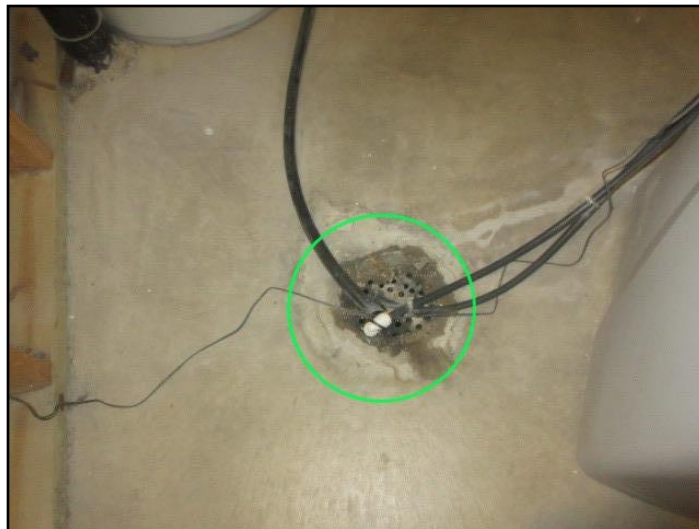
20. Condition: • The condensate drain lines coming to the floor drain are in contact with the floor drain. There should be at least a 1.5" air break/gap between the floor drain & condensate hoses.

Floor Drain

Recommend adding a block under the condensate hoses or adding appropriate inserts to the ends of the hoses to achieve this for added protection of units connected to the drain line hoses in case of a backup at the floor drain that could potentially allow for siphoning and bacteria growing up the condensation lines.

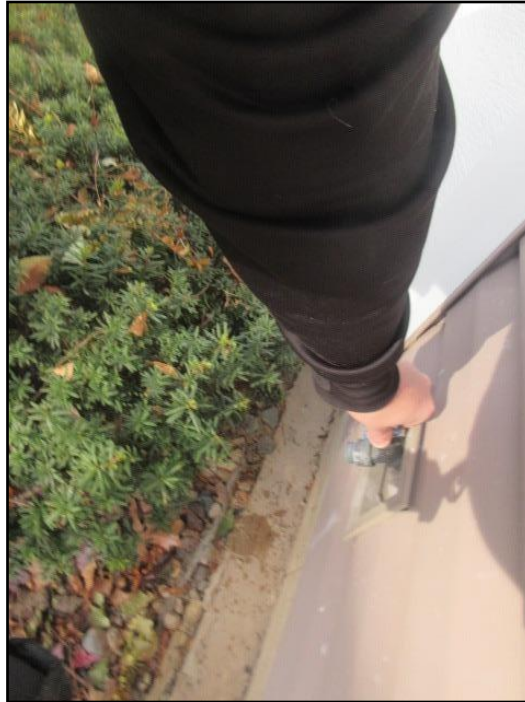
21. Condition: • [Inoperative](#)

Front Spigot Not Operable

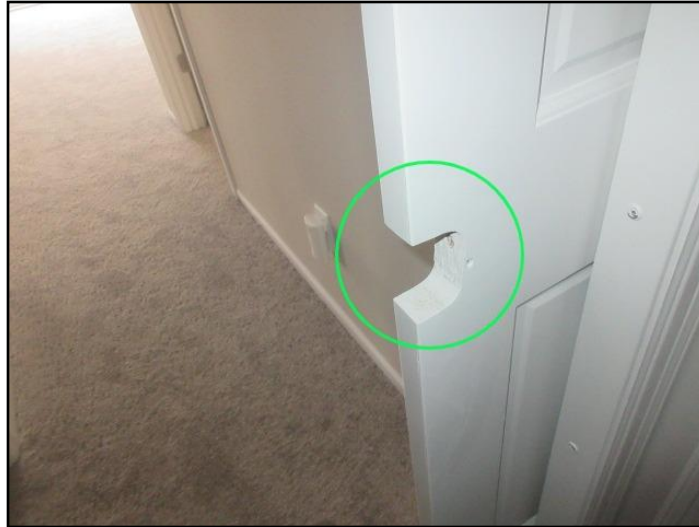
- Doors missing, damaged, or reduced functionality present.

Entry Pocket Door Missing Hardware

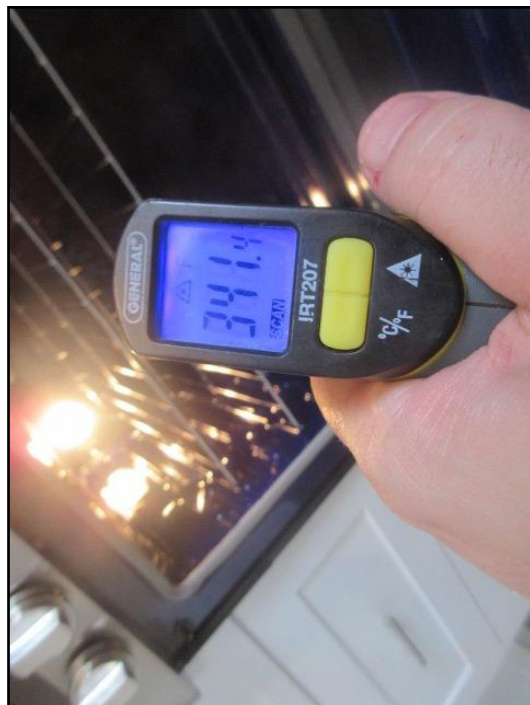
341 Set @ 350 Degrees

Add metal thermostats to ovens that are outside 20 degrees of calibration. Continue to monitor to better gauge plan of action. Temperature probes can go out and need replacing or considerations for upgrading.

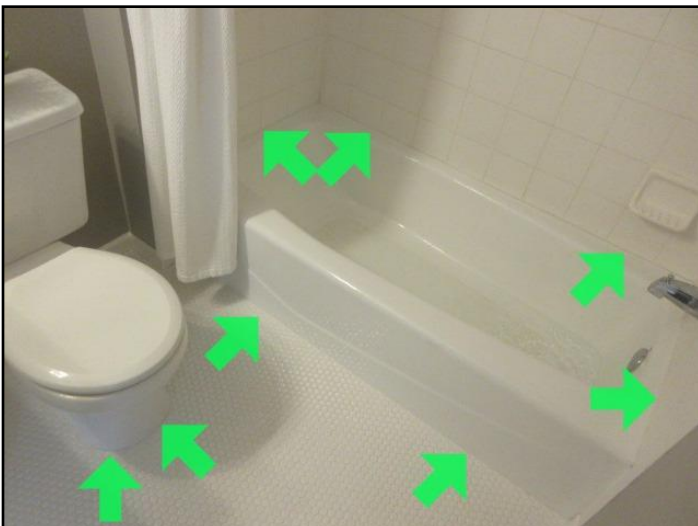
Common Bath

24. Condition: • Maintenance Hints: Windex Trick For Applying Silicone. Apply a small (thin) bead of the area that you want to seal; Spray all surfaces with WINDEX; Tool the silicone into place with your finger, wiping your finger of the excess as you go; Re-spray the area with WINDEX, then tool the area with your finger again. For straight lines use painters tape, apply tape on each side of caulk line. Apply caulking, tool the line, and remove tape as caulk is still wet.

The use of a POLYURETHANE based sealant is preferred over the use of silicone for EXTERIOR applications. The use of 100% SILICONE sealant is recommended for all interior areas around potable water. (sinks, toilets, backsplashes) Silicone is resistant to many of the common bacteria's.

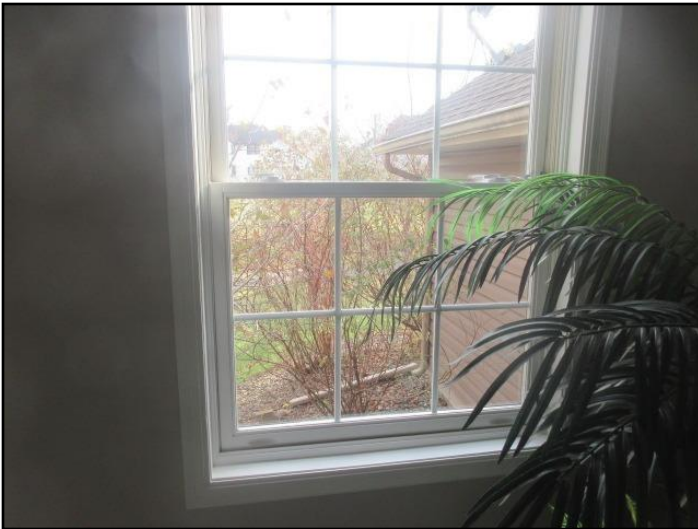
25. Condition: • Inoperative

Main Level Right BR Window Inoperative

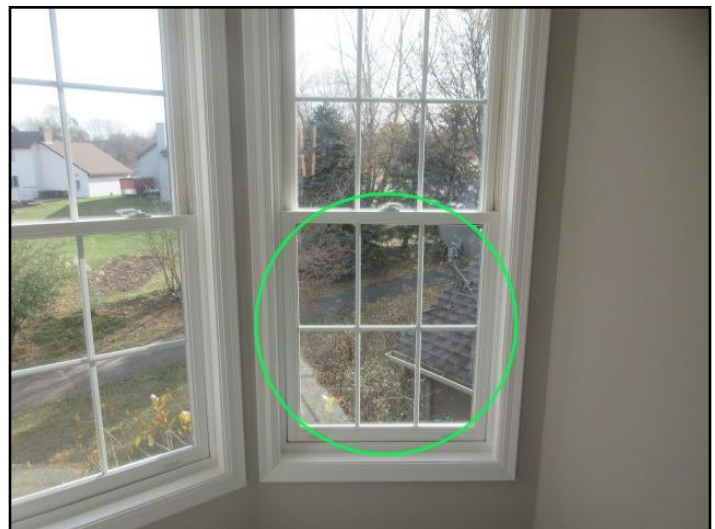
Master Bedroom Inoperative Window

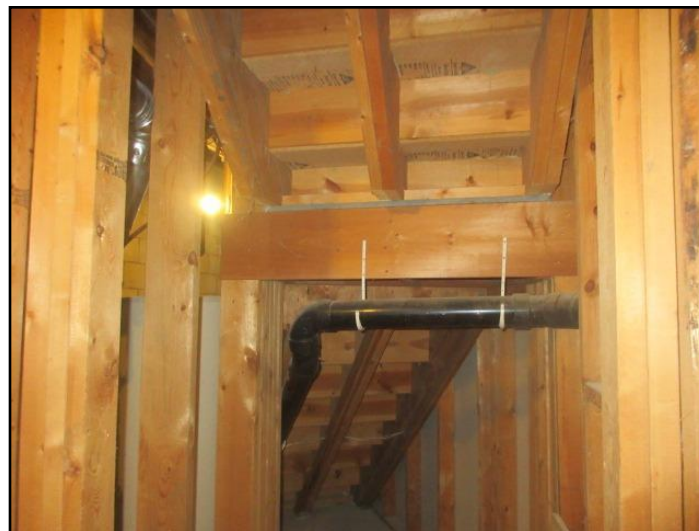
Under The Stairs

Implication(s): Increased fire hazard

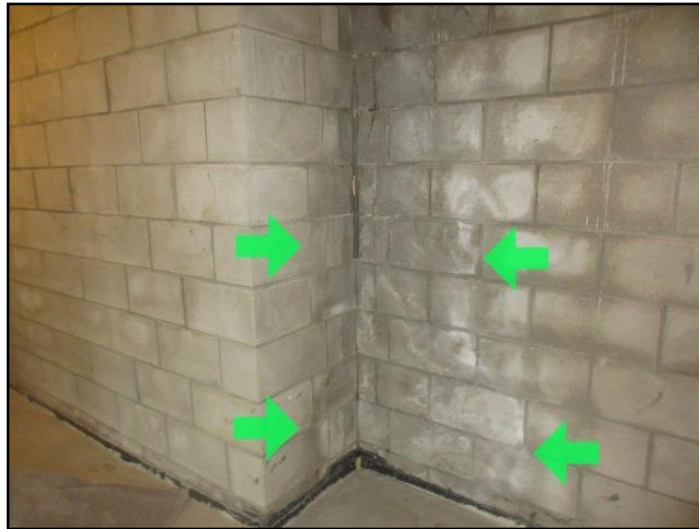
Front Bsmt. Wall

30. Condition: • Efflorescence is a crystalline deposit of salts that can form when water is present in or on brick,

concrete, stone, stucco or other building surfaces. It has a white or greyish tint and consists of salt deposits left behind when water evaporates. In summary, efflorescence is a cosmetic issue, but it indicates a potential or previous moisture problem.

Efflorescence is a crystalline deposit of salts that can form when water is present in or on brick, concrete, stone, stucco or other building surfaces. It has a white or greyish tint and consists of salt deposits left behind when water evaporates. In summary, efflorescence is a cosmetic issue, but it indicates a potential moisture problem.

It is recommended to clean the areas to make monitoring easier.

Clean and continue to monitor area. It is most likely from before the repairs were made.

Seal cracks with "Vulkem".

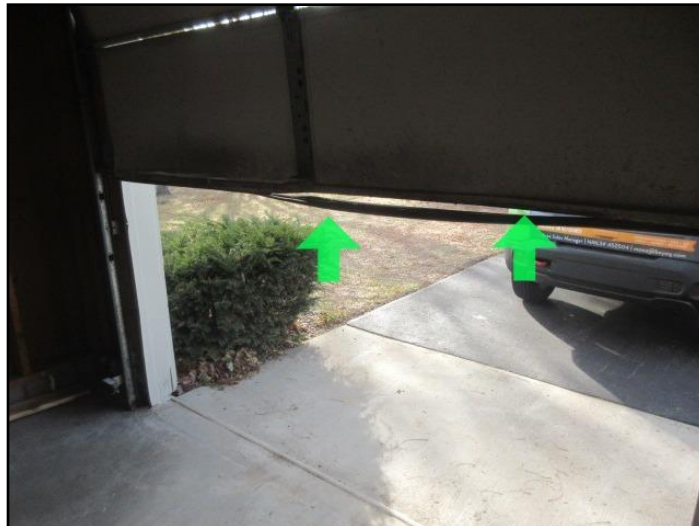
31. Condition: • Repair or replace weather strip trim to protect against water intrusion.

Failing Weather Stripping

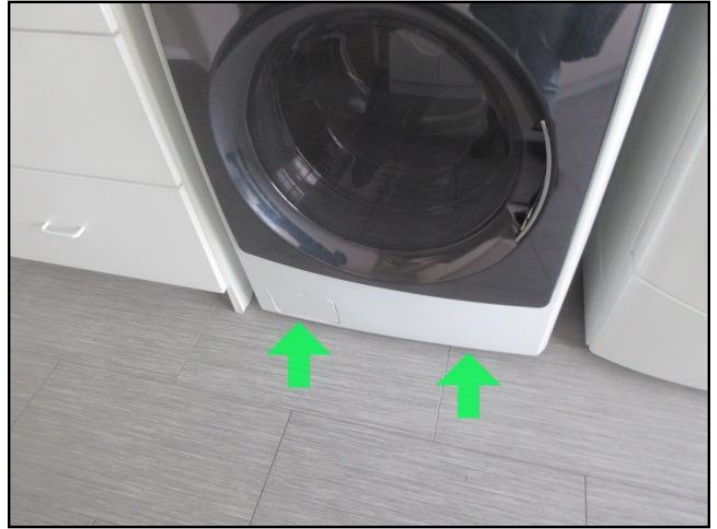
32. Condition: • Drip pan missing

No Drip Pan On Main Floor Laundry

Add a drip pan under the washer to prevent potential water damage if failure occurs.

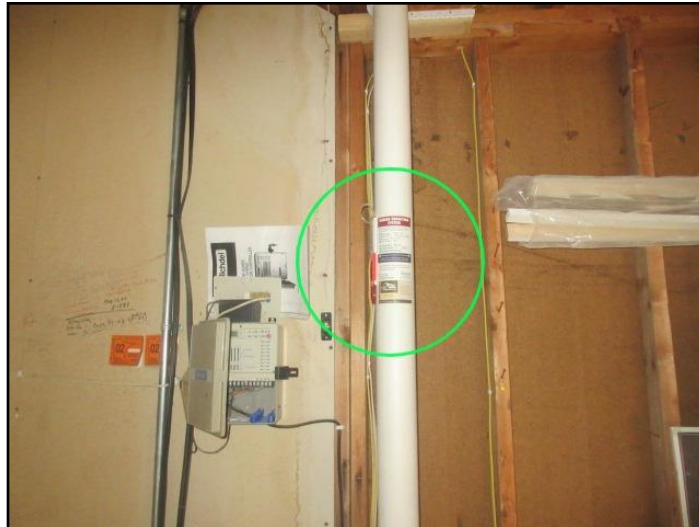
Manometer

To ensure fan is running you should always see separation between two red vials.

If property tests high a second suction point would be needed.
